Manhole Inspection Summary

Manhole # S150O1001MH

Insp Date: **10/7/08 12:47 PM**

Location Address: **4991 YELLOWWOOD AVE**

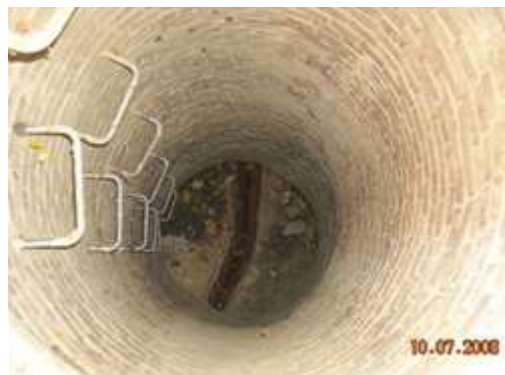
Top View

Corbel and Barrel infiltration. Evidence of surcharge - Bench debris.

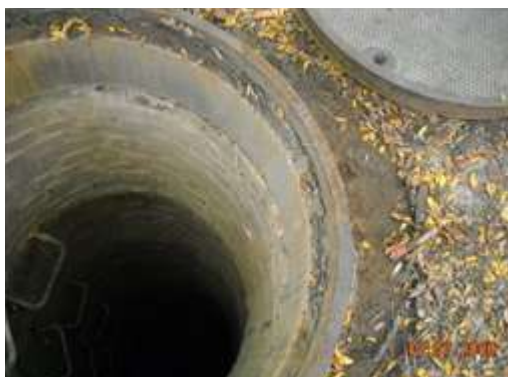
Defect

Comments **COMPLETED BY REI/DRAYCO.ORIGINAL INSPECTION BY RK&K CREW: WM, BC 05/06/08. FRAME ORIGINALLY OFFSET BY 4 INCHES AND NOT SEALED TO STRUCTURE; RESET FRAME & COVER SO THERE WAS NO OFFSET**

Moved the frame back over the MH. This still needs to be repaired.

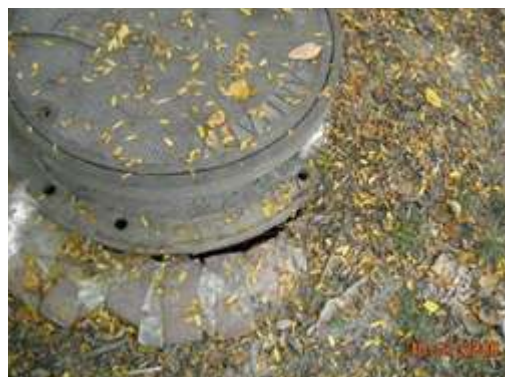
Defect

The frame is not attached.

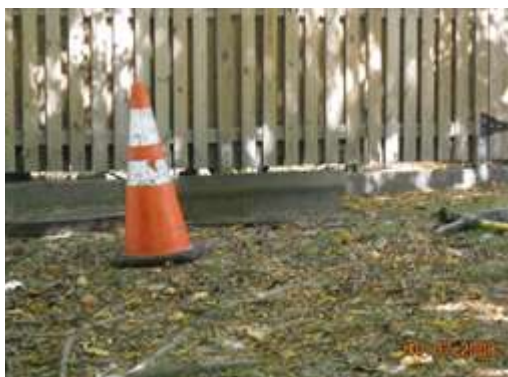
Defect

Above grade.

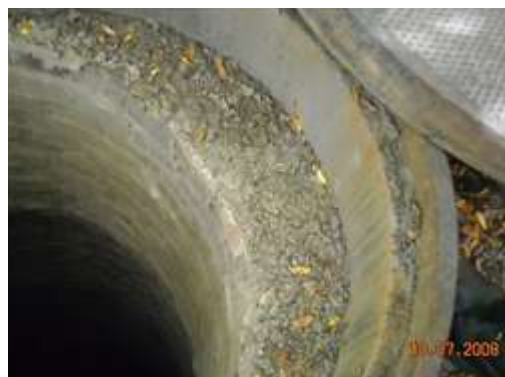
Defect

The frame is not attached.
